LANDSLIDES AND RELATED FEATURES

OF THE TRACE, W. VA., QUADRANGLE

by
William F. Outerbridge
1982

OPEN FILE MAP 82-51 (H-15)

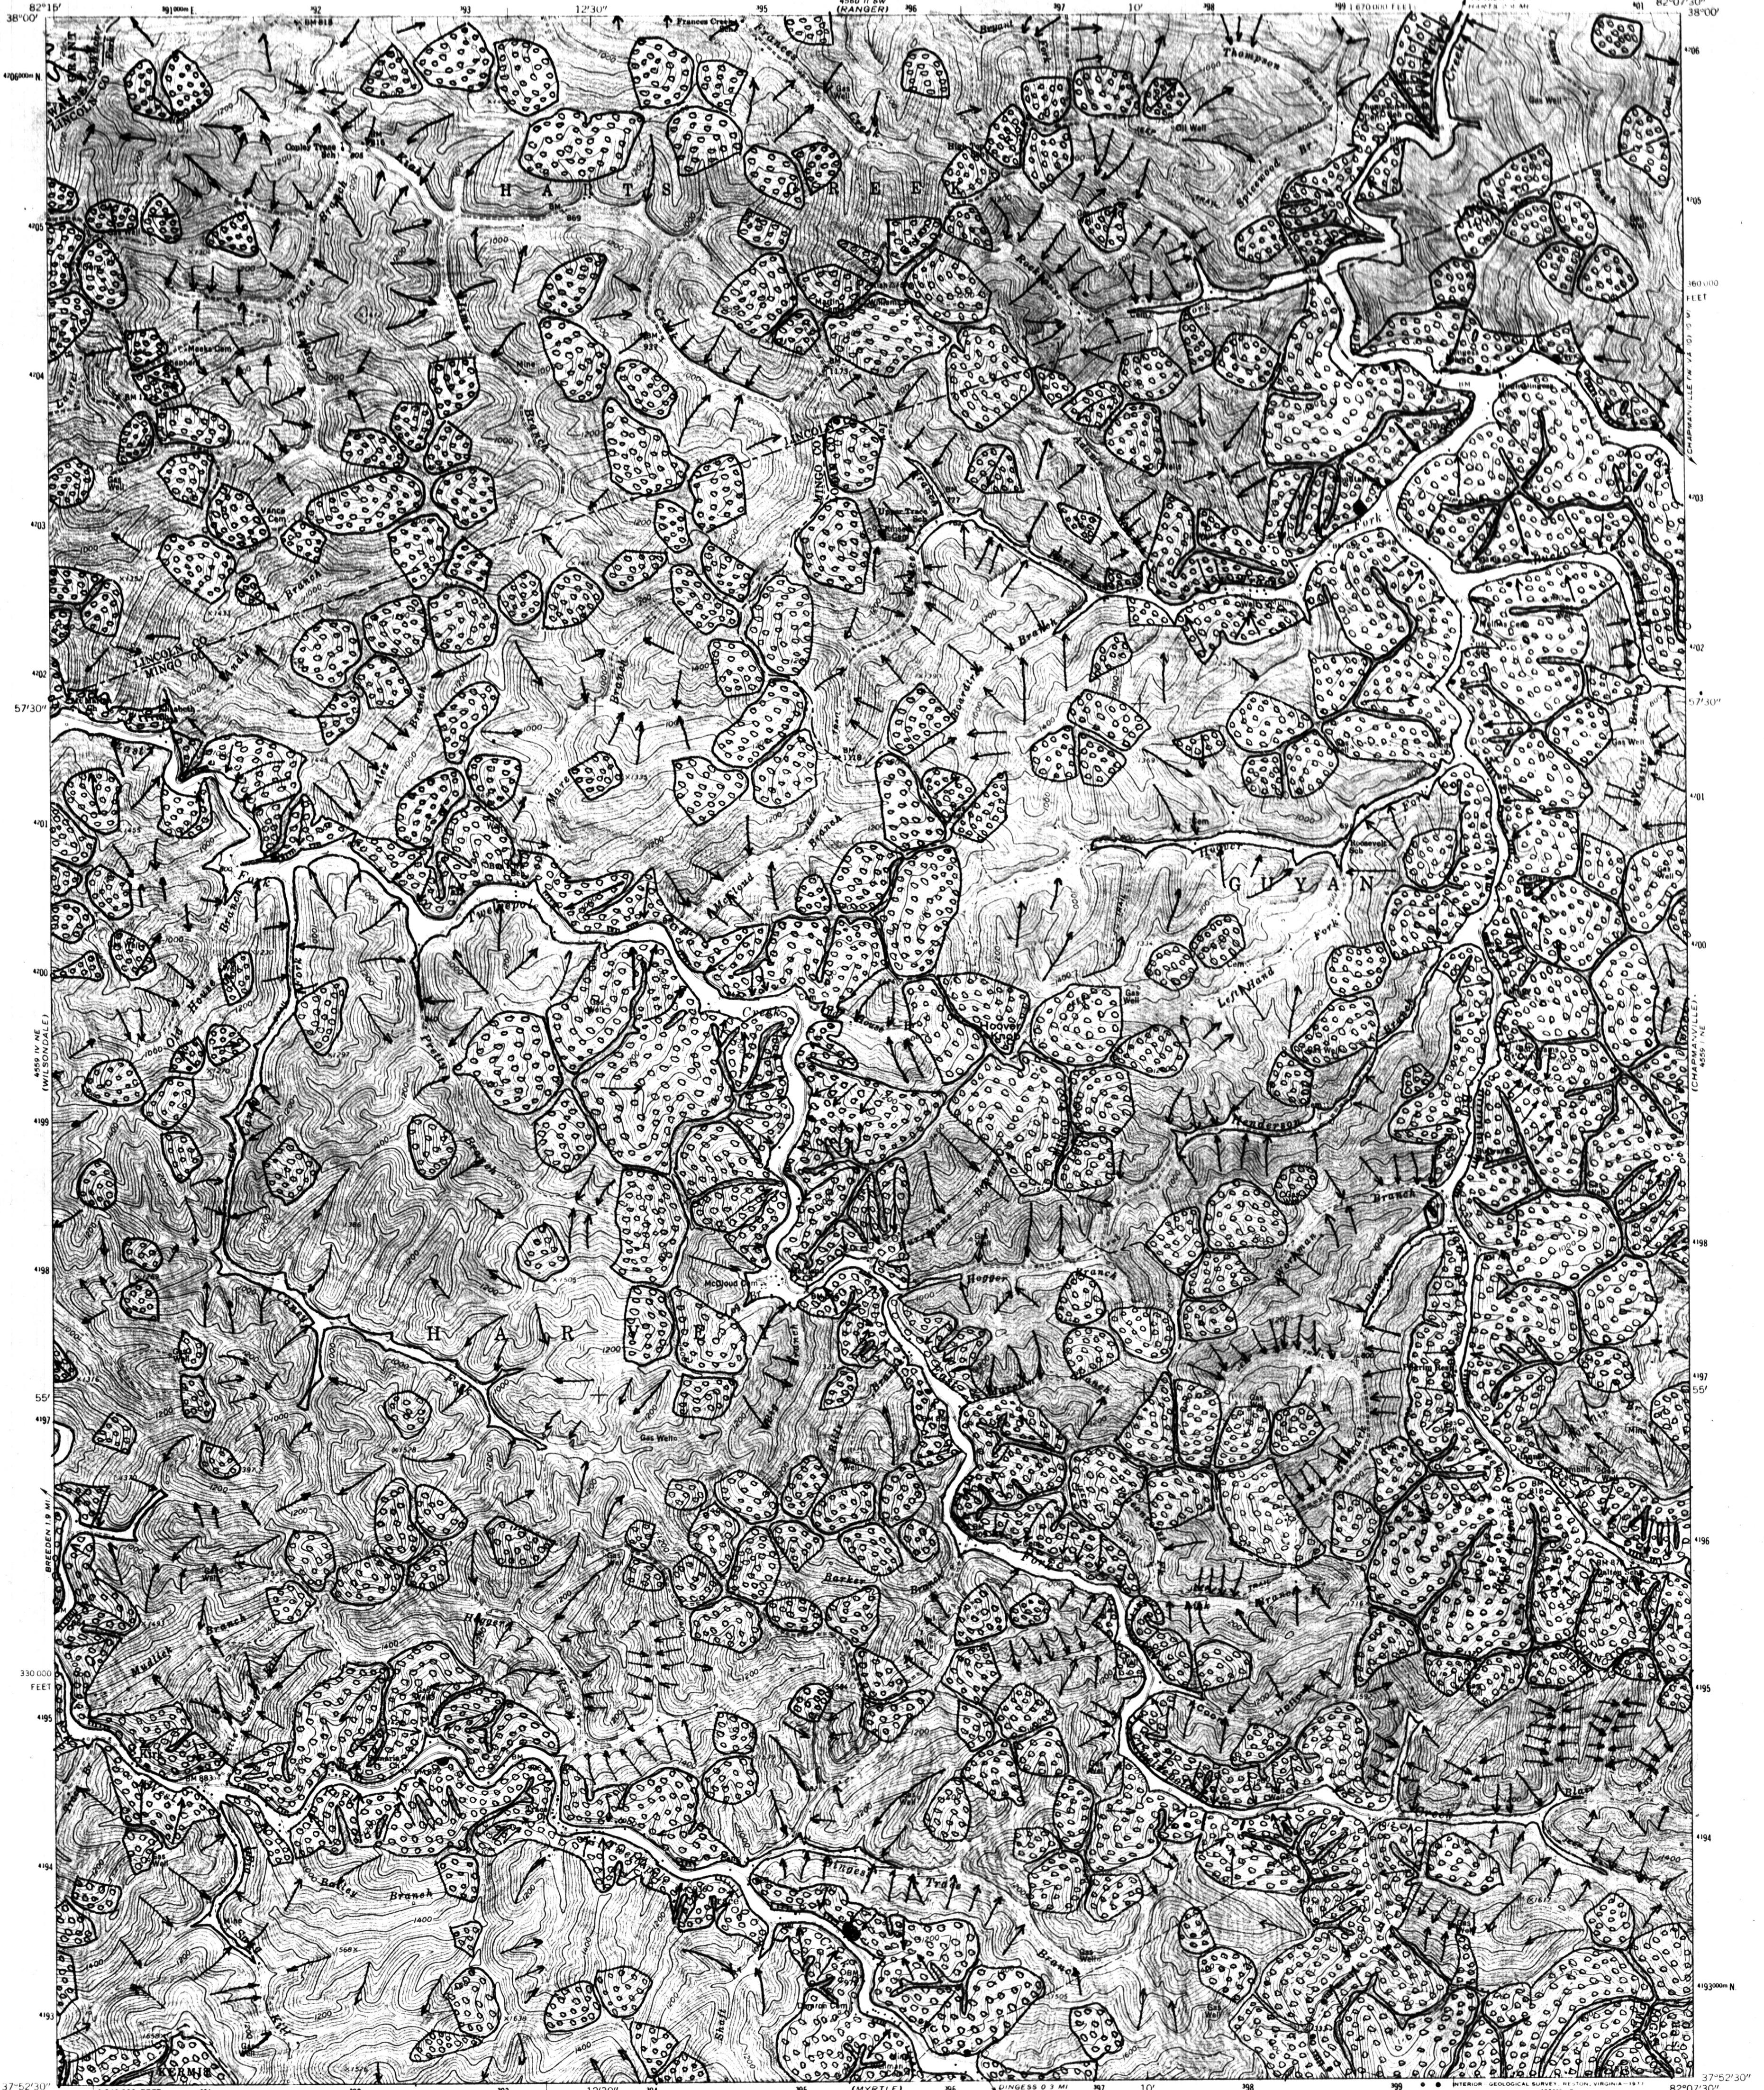
Landslides and related features interpreted
from aerial photographs:
1:60,000 (black and white) 1959
1:125,000 (color Infrared) 1973

Photointerpretation and field check 1977
This report is preliminary and has not
been reviewed for conformity with U. S.
Geological Survey editorial standards.

ACTIVE OR RECENTLY ACTIVE LANDSLIDE

Complex landslide composed of earthflow, debris
slide, earth and rock slump. Identified from
historical records, and from scars, debris and
other field evidence. Ground extremely unstable;
sliding accelerated by excavation, loading and
changes in drainage conditions. May include
areas with several active slides too small to
be shown separately. Questioned where doubtful.

OLD LANDSLIDE

Area of extensive hummocky ground caused by
earthflow and earth and rock slump. Lacks
clear evidence of active sliding. Relatively
stable in natural, undisturbed state,
generally not affected by small structures properly
sited in areas away from the edge of the toe;
can be reactivated by extensive, rapid excava-
tion, loading, and changes in ground water and
surface water conditions. Area of old landslide
probably includes recent ones not identified
from field evidence or otherwise documented.
Upslope boundary of landslide generally defined
by modified scarp, but downslope (toe) may be
gradational and not well defined. Questioned
where doubtful.

COLLUVIAL SLOPE

Valley wall along major streams with slope as
steep as 40° (85%); stony, clayey silt soil up
to 50 ft. (15 m) thick; commonly buttressed by
a terrace or bench at the toe of the slope; very
susceptible to sliding by cutting of toe area,
removal of terrace or bench, and overloading;
slide commonly activated without apparent cause.

AREAS SUSCEPTIBLE TO DEBRIS FLOWS AND DEBRIS AVALANCHES

Primarily shallow, narrow ravines and chutes with
accumulation of stony colluvium generally 10 ft.
(3 m) or less in thickness; susceptible to rapid
movement during intense rainfall. Most ravines
and chutes designated show evidence of former
debris flows and avalanches. Symbol & design-
ates historical debris flow or debris avalanche.

AREAS SUSCEPTIBLE TO ROCKFALL

Steep, locally vertical, natural and man-made
slopes and cliffs, 15 ft. (4.5 m) or more high;
formed dominantly of sandstone, limestone, sandy
shale, mudstone and claystone. Interbedded mud-
stone, claystone and shale weather rapidly leaving
sandstone and limestone rock faces unsupported.

SOIL AND ROCK SUSCEPTIBLE TO LANDSLIDING

Soil and rock similar to that involved in land-
slides elsewhere in map area; primarily areas
underlain by claystone, mudstone and shale
associated with other rock types. Rock weathers
rapidly on exposure forming clayey soil highly
susceptible to sliding. Includes coves (U-shaped,
shallow valleys) containing thick layers of clayey
soil that are very susceptible to sliding where
excavation breaks continuity of slope and where
overloaded by artificial fill.
